# Impact Testing on Reinforced Carbon-Carbon Flat Panels With Ice Projectiles for the Space Shuttle Return to Flight Program

*Matthew E. Melis, Duane M. Revilock, and Michael J. Pereira  
Glenn Research Center, Cleveland, Ohio*

*Karen H. Lyle  
Langley Research Center, Hampton, Virginia*

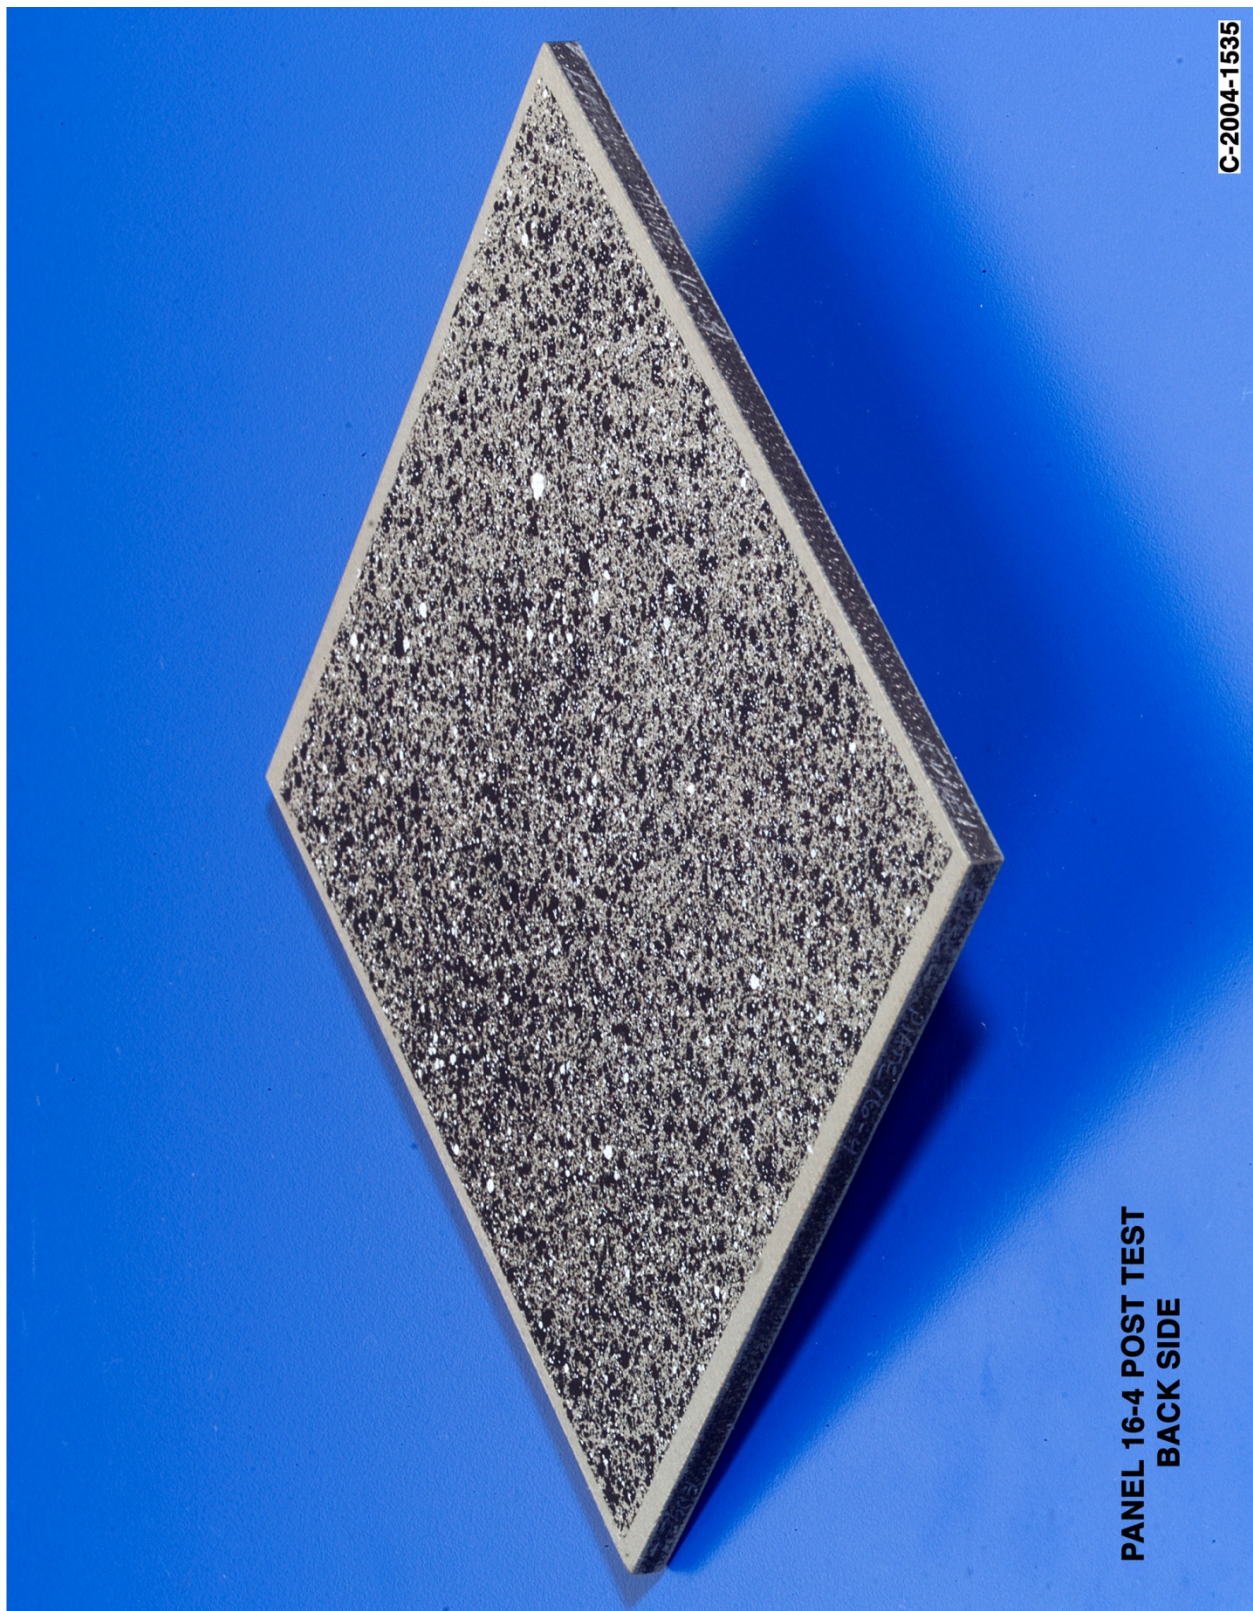
Figure A5-3.—Back face of panel 16-4 at 240 ft/s with a high-density, poly-crystal ice cylinder (nominally 0.66 in. in diameter by 1.66 in.) at 90° impact angle. Test GRCC 78.

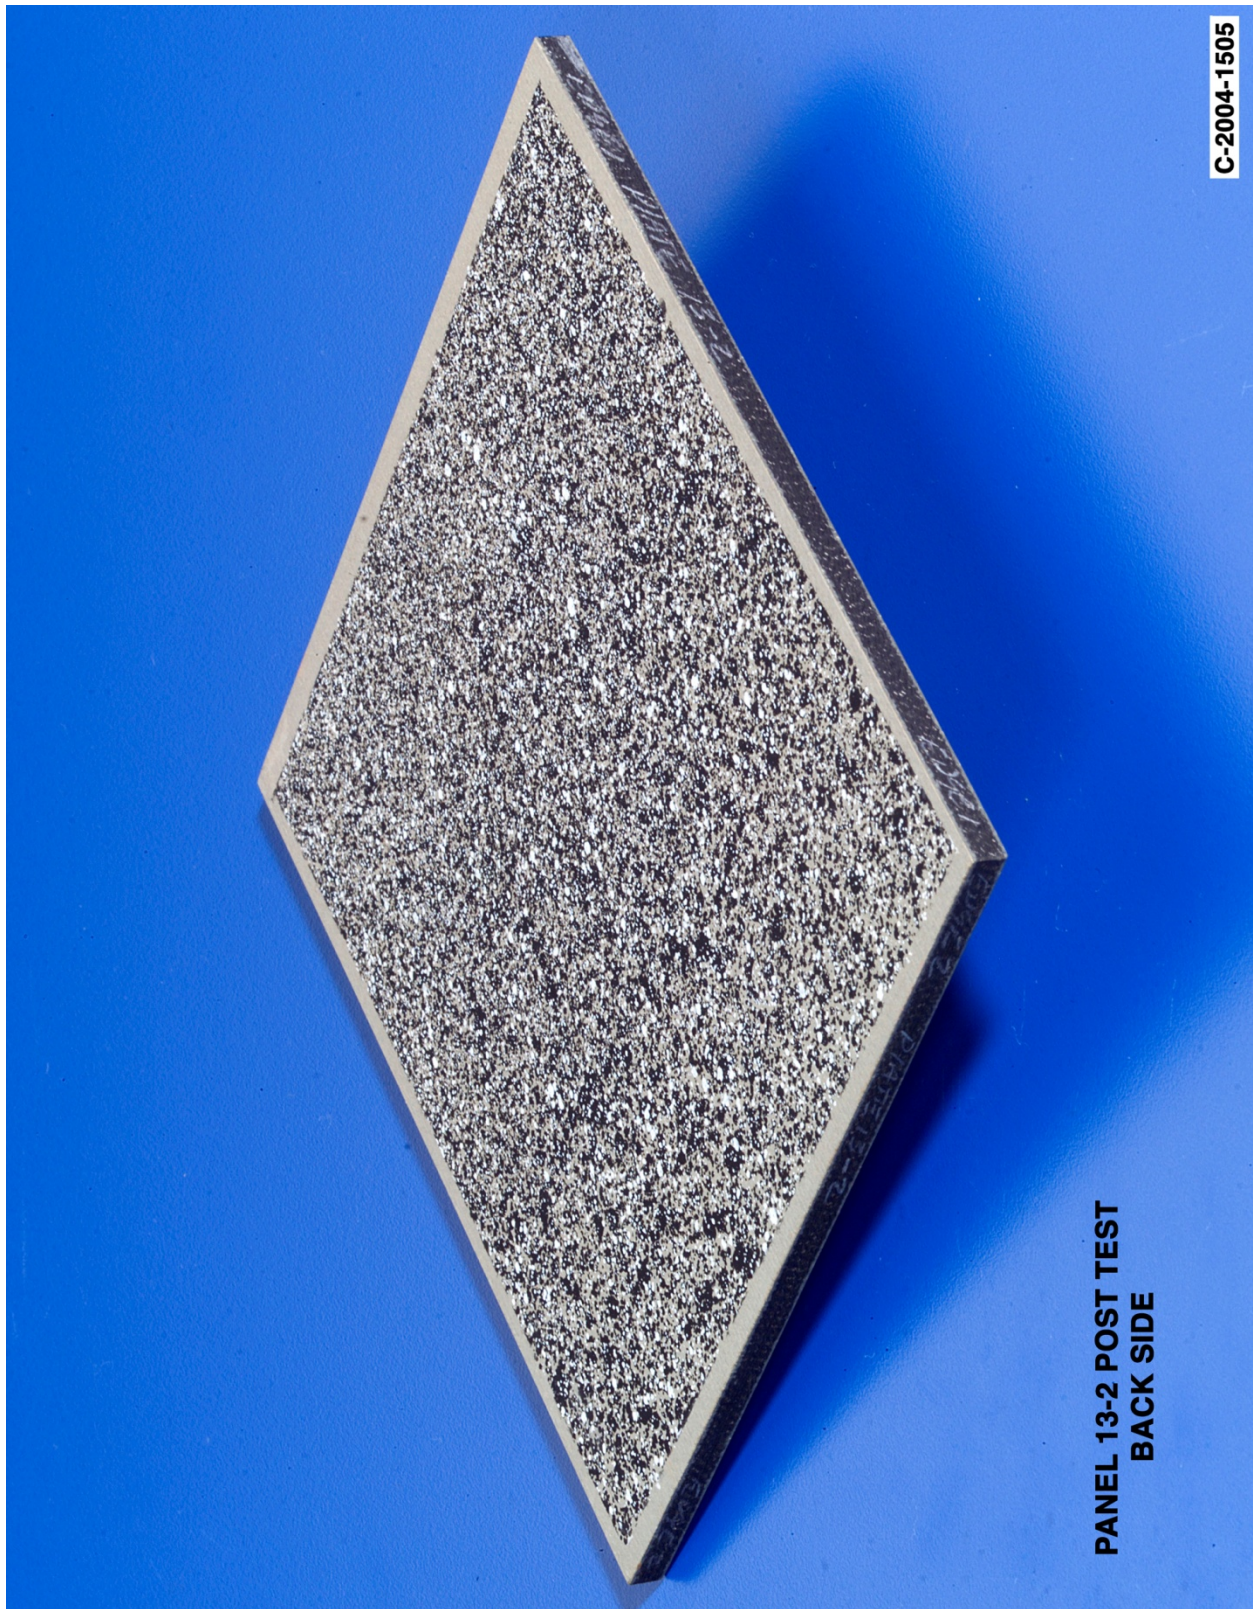
Figure A6-3.—Back face of panel 13-2 at 290 ft/s with a high-density, poly-crystal ice cylinder (nominally 0.66 in. in diameter by 1.66 in.) at 90° impact angle. Test GRCC 67.

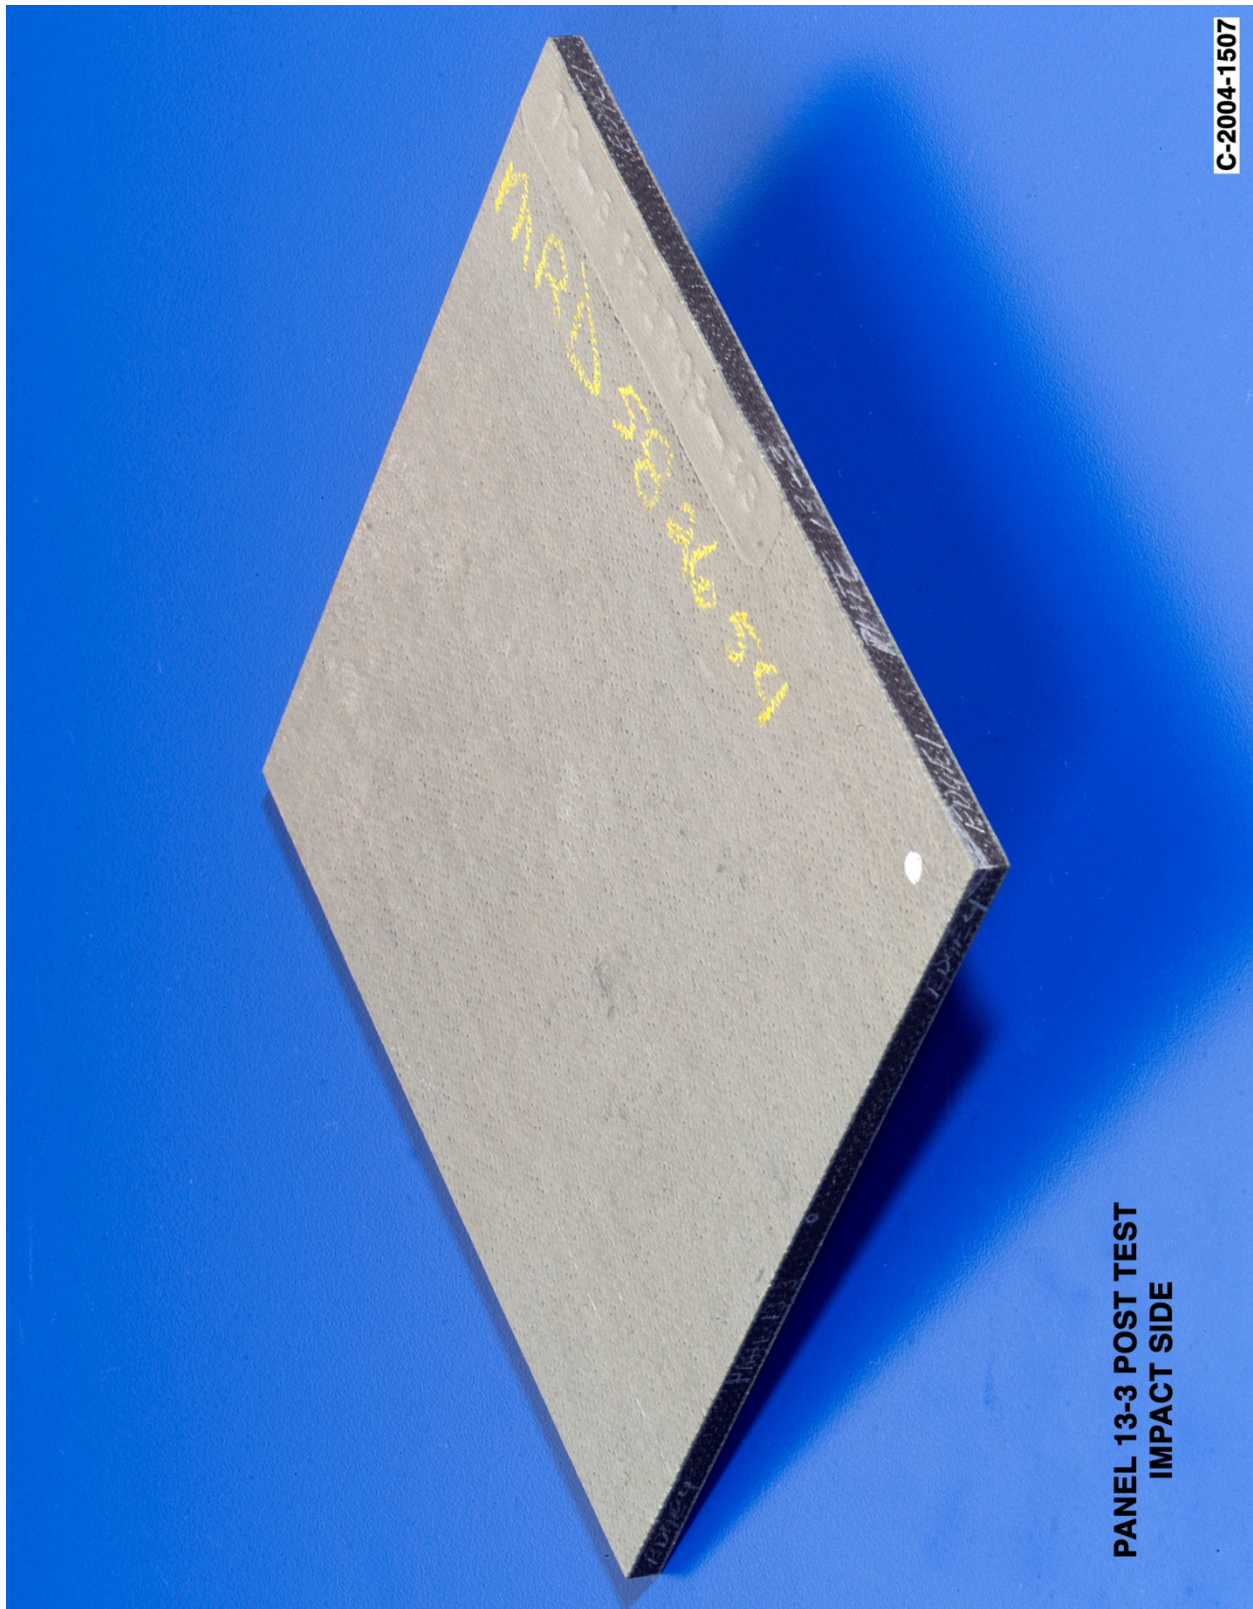
Figure A7-2.—Front (impact side) of panel 13-3 at 438 ft/s with a high-density, poly-crystal ice cylinder (nominally 0.66 in. in diameter by 1.66 in.) at 90° impact angle. Test GRCC 68.

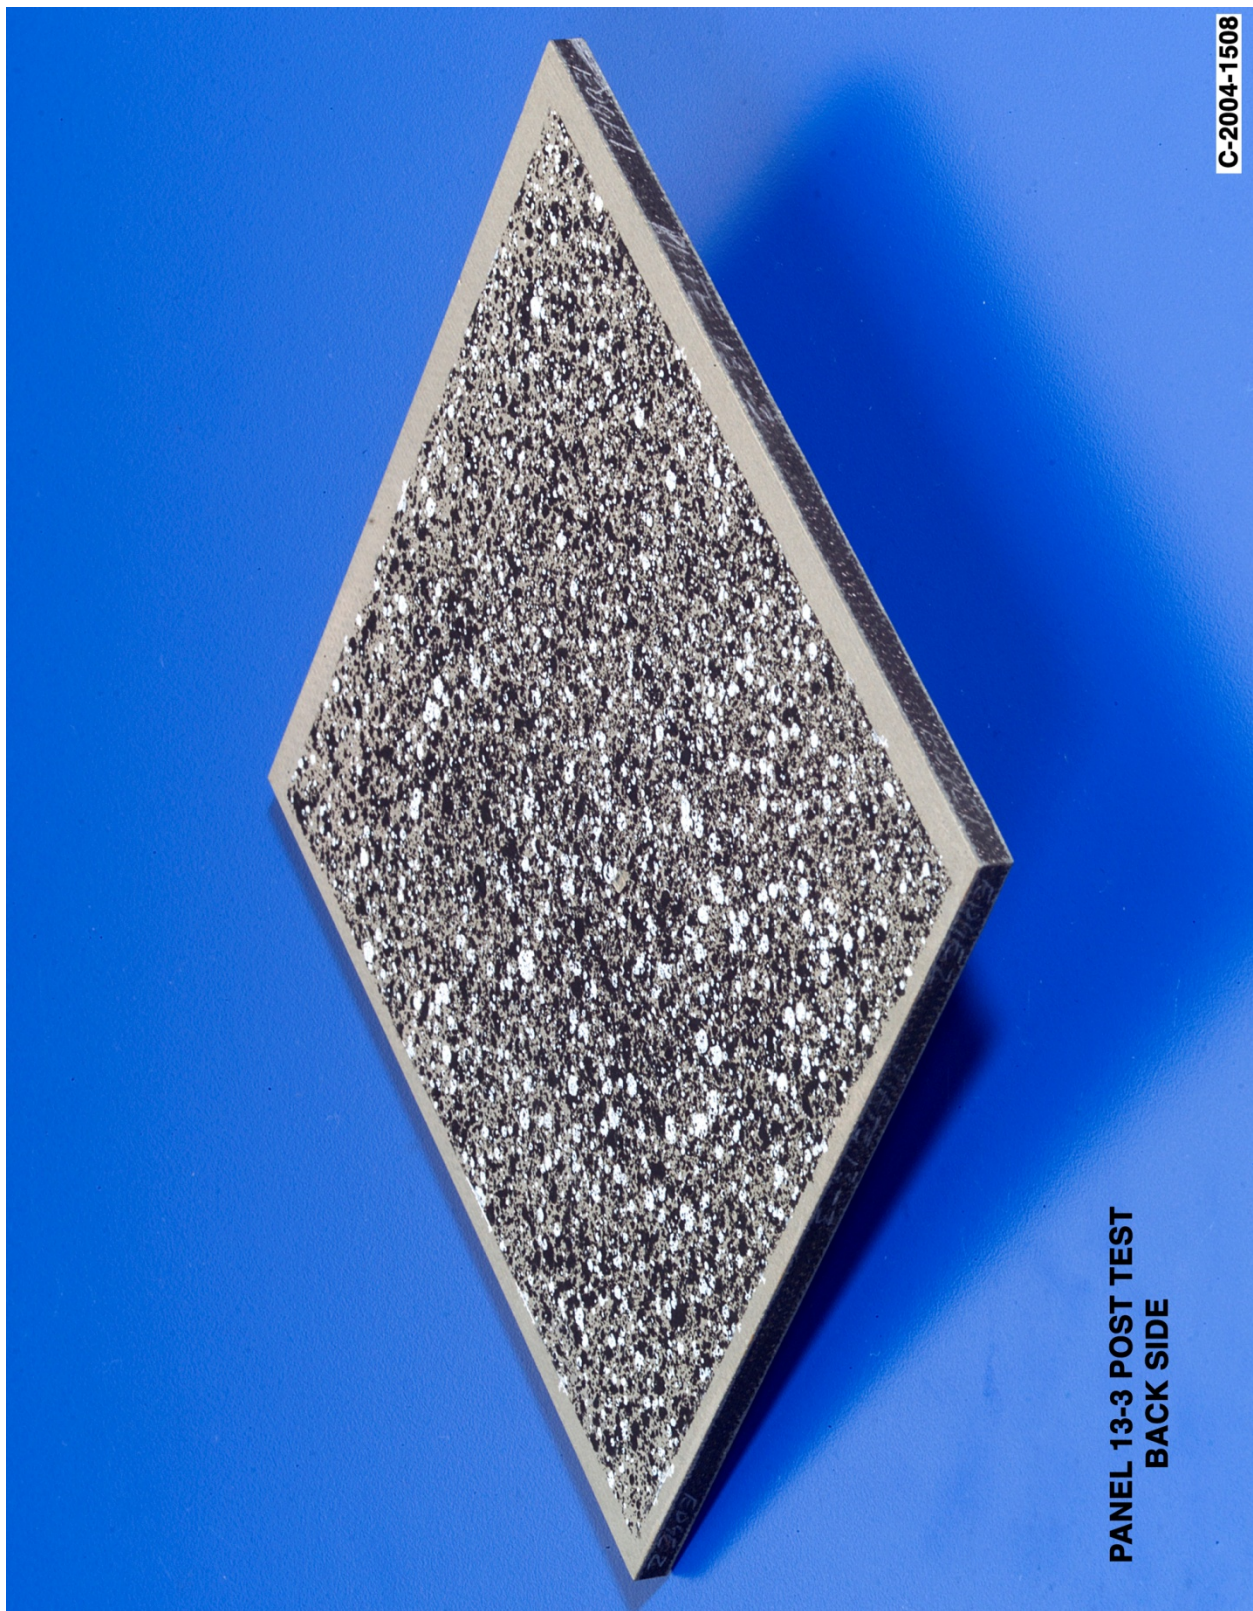
Figure A7-3.—Back face of panel 13-3 at 438 ft/s with a high-density, poly-crystal ice cylinder (nominally 0.66 in. in diameter by 1.66 in.) at 90° impact angle. Test GRCC 68.

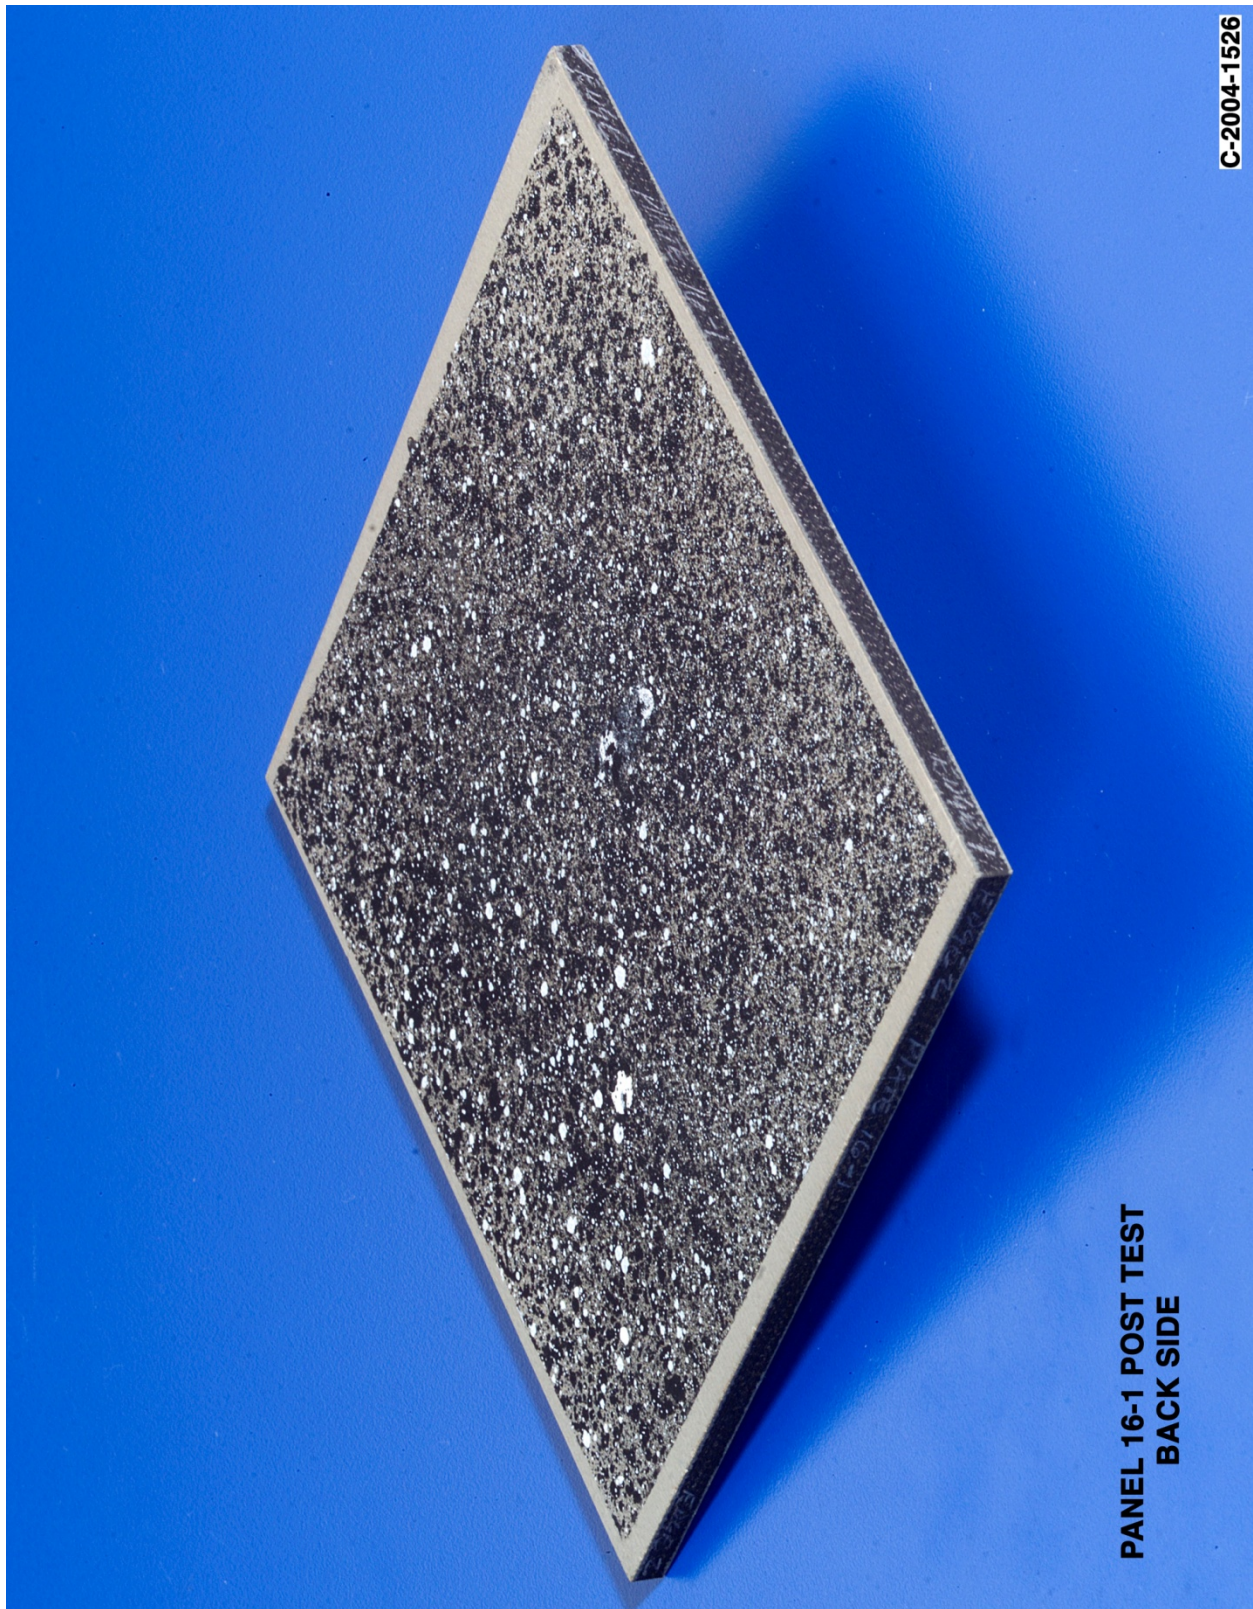
Figure A9-3.—Back face of panel 16-1 at 474 ft/s with a high-density, poly-crystal ice cylinder (nominally 0.66 in. in diameter by 1.66 in.) at 90° impact angle. Test GRCC 74.

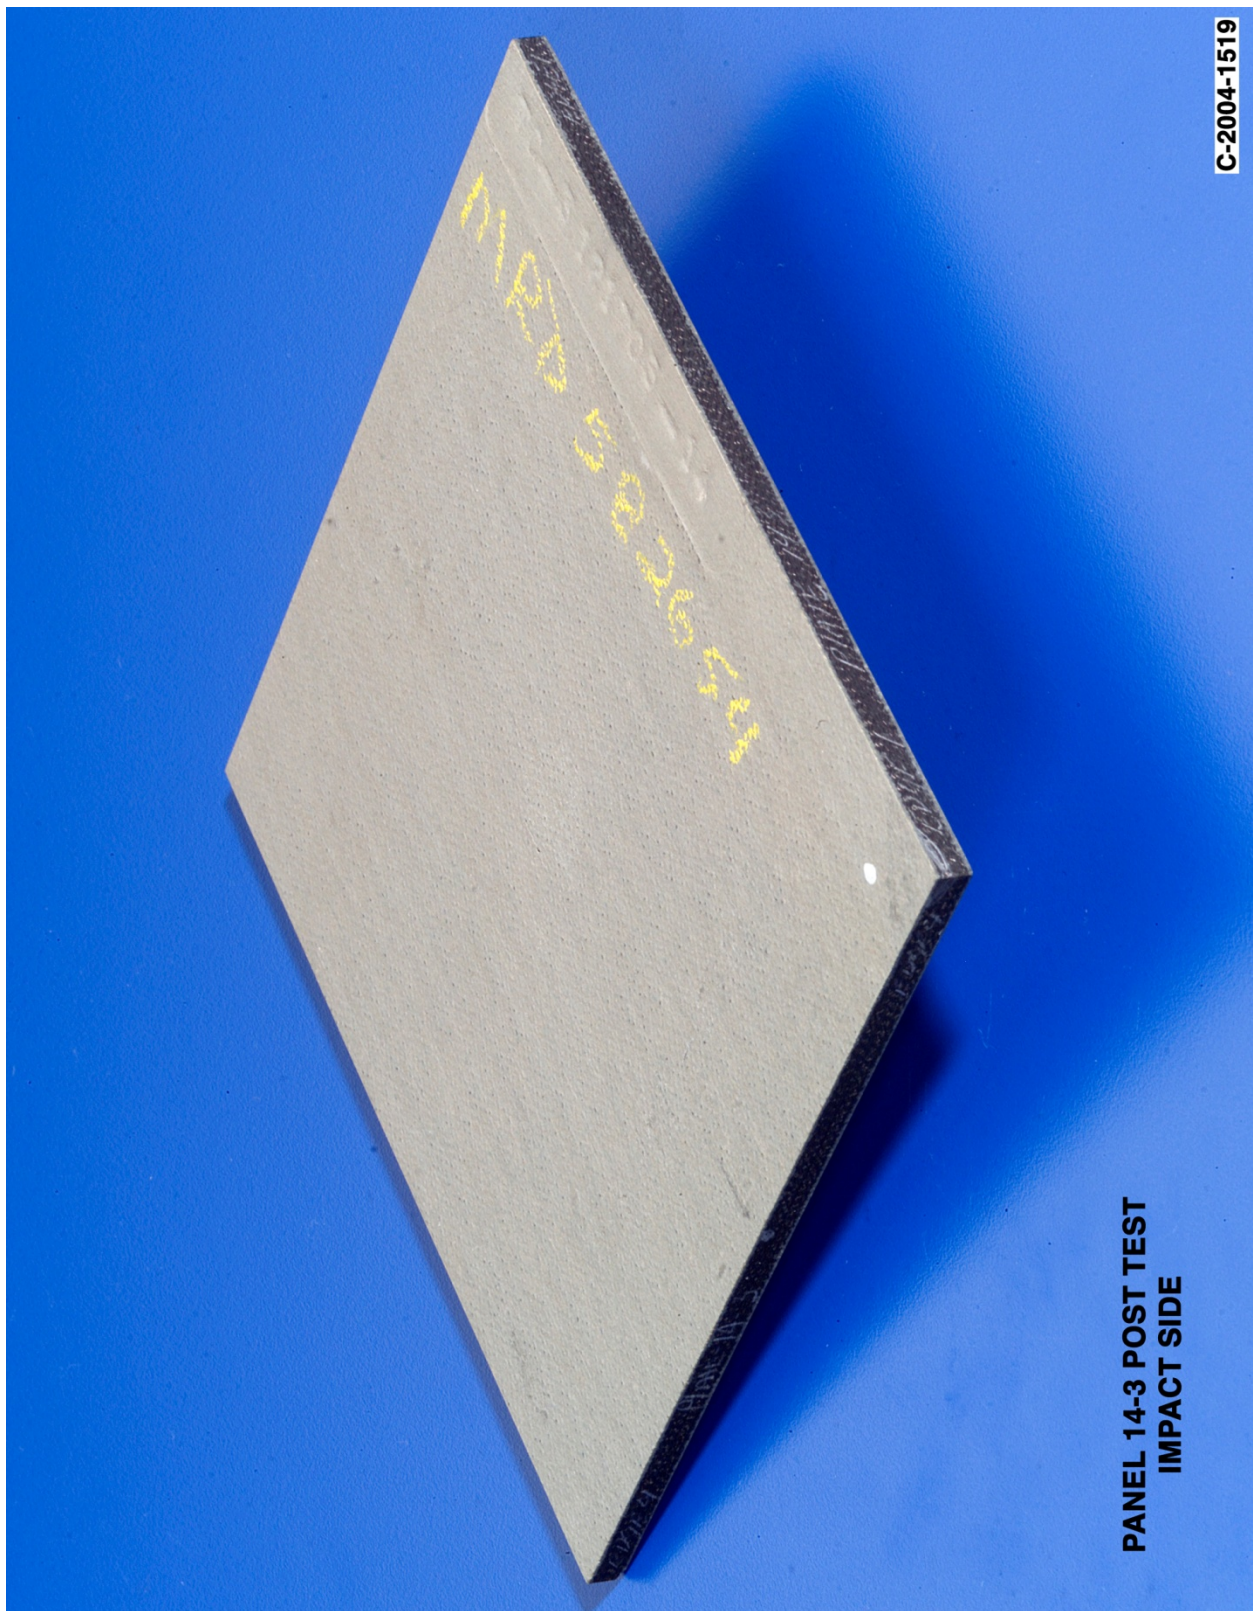
C-2004-1519

Figure A13-2.—Front (impact side) of panel 14-3 at 495 ft/s with a high-density, poly-crystal ice cylinder (nominally 0.66 in. in diameter by 1.66 in.) at 90° impact angle. Test GRCC 72.

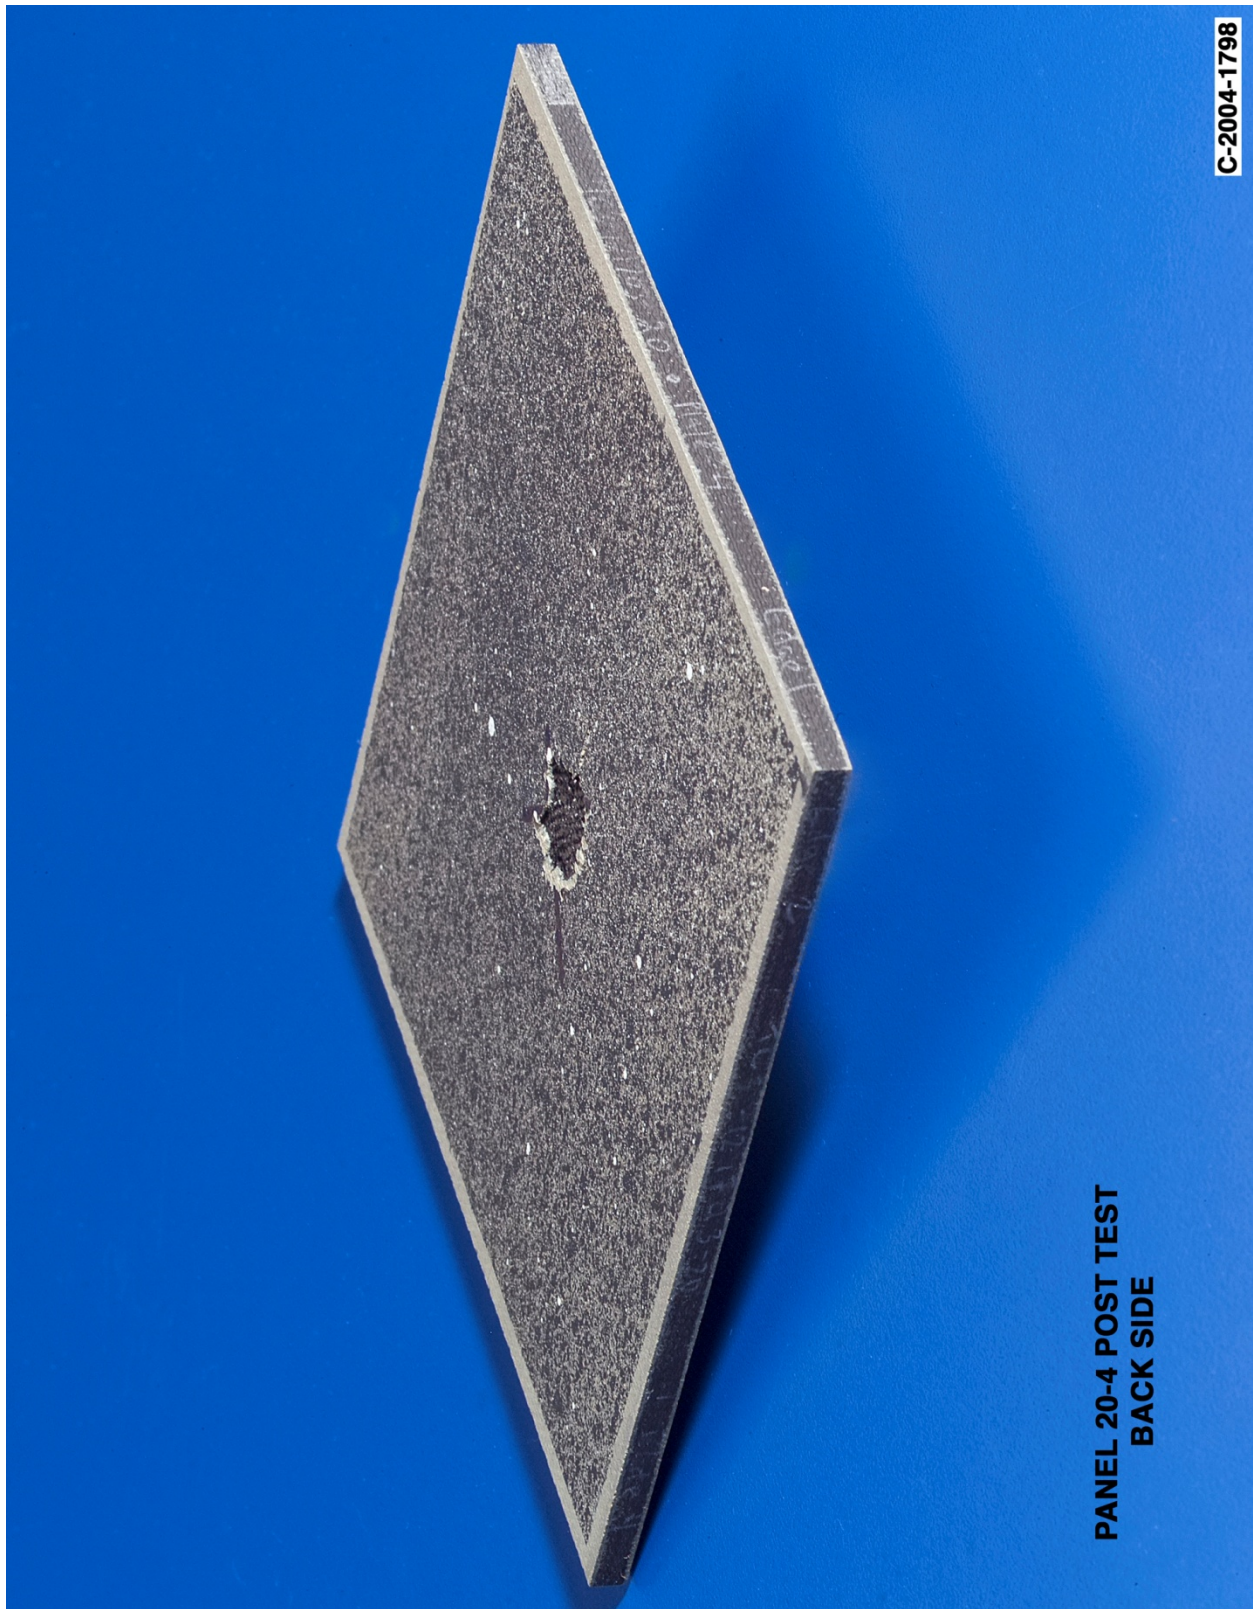
Figure A15-3.—Back face of panel 20-4 at 498 ft/s with a high-density, poly-crystal ice cylinder (nominally 0.66 in. in diameter by 1.66 in.) at 90° impact angle. Test GRCC 113.

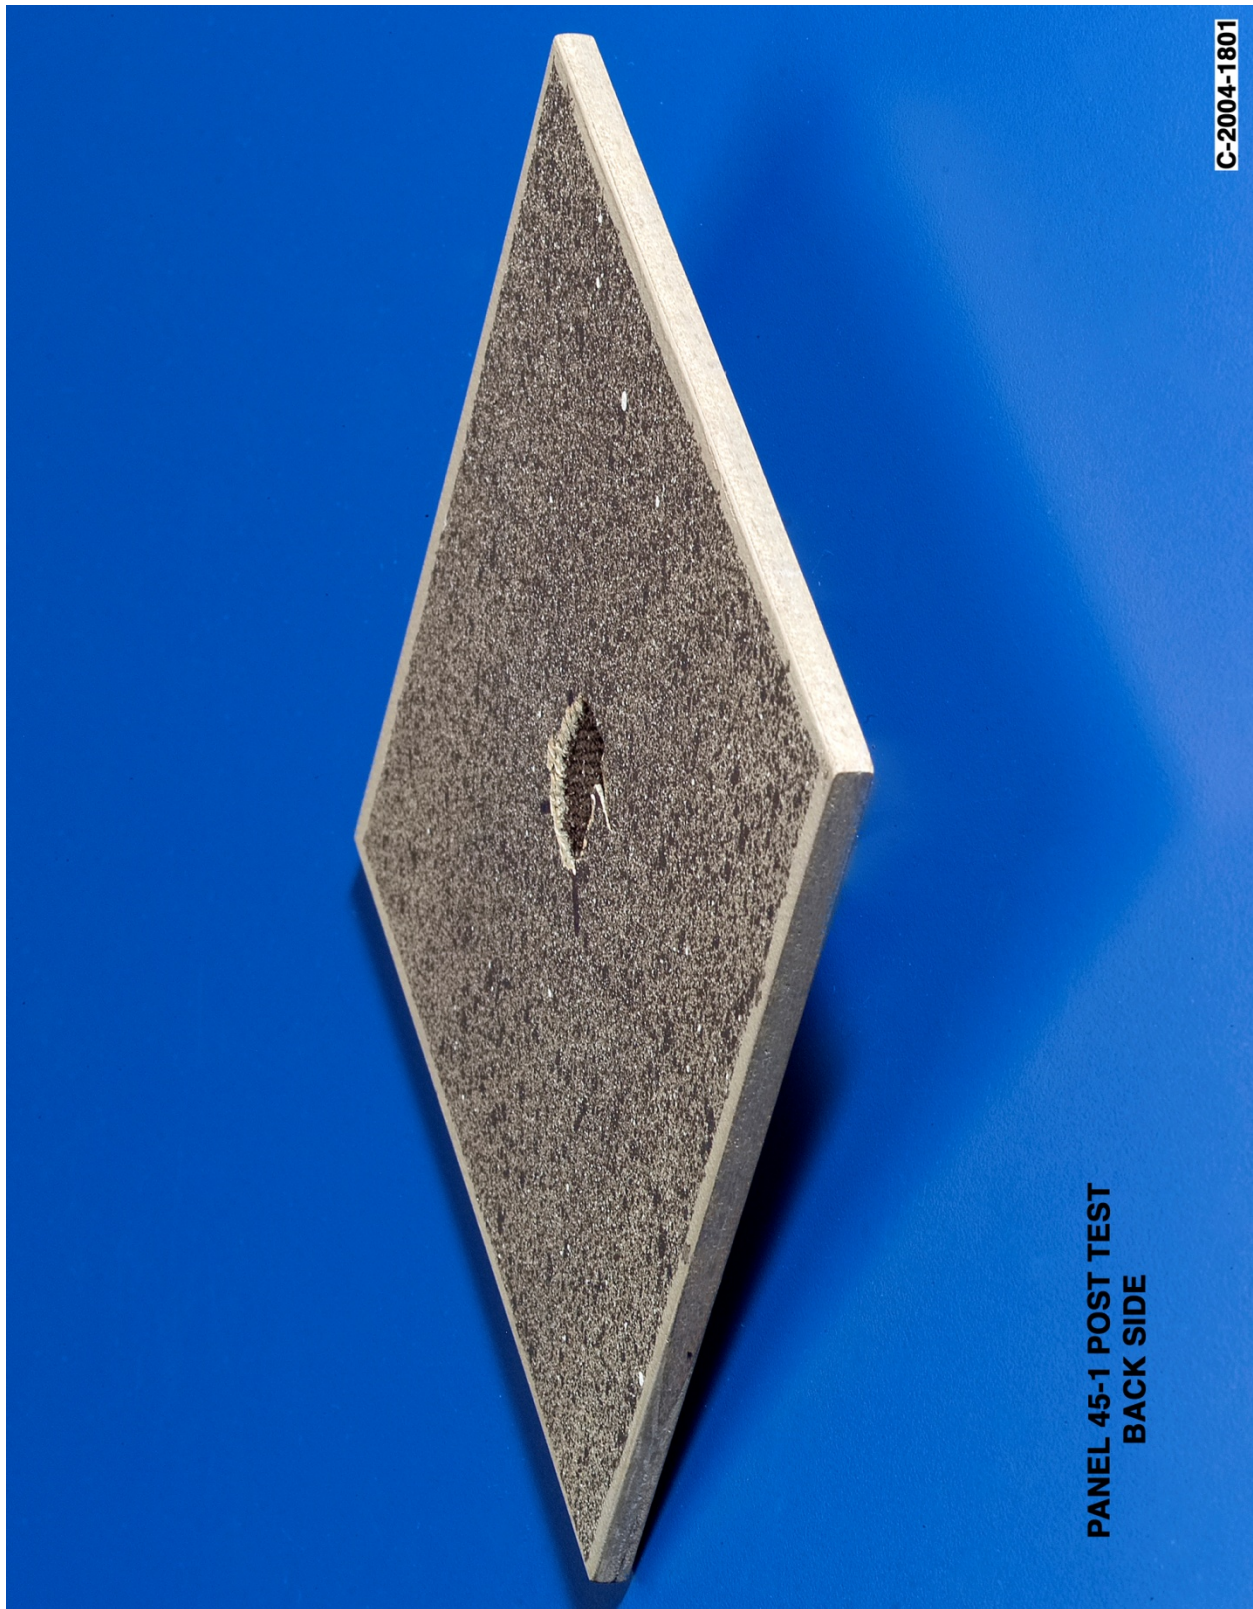
Figure A17-3.—Back face of panel 45-1 at 509 ft/s with a high-density, poly-crystal ice cylinder (nominally 0.66 in. in diameter by 1.66 in.) at 90° impact angle. Test GRCC 114.

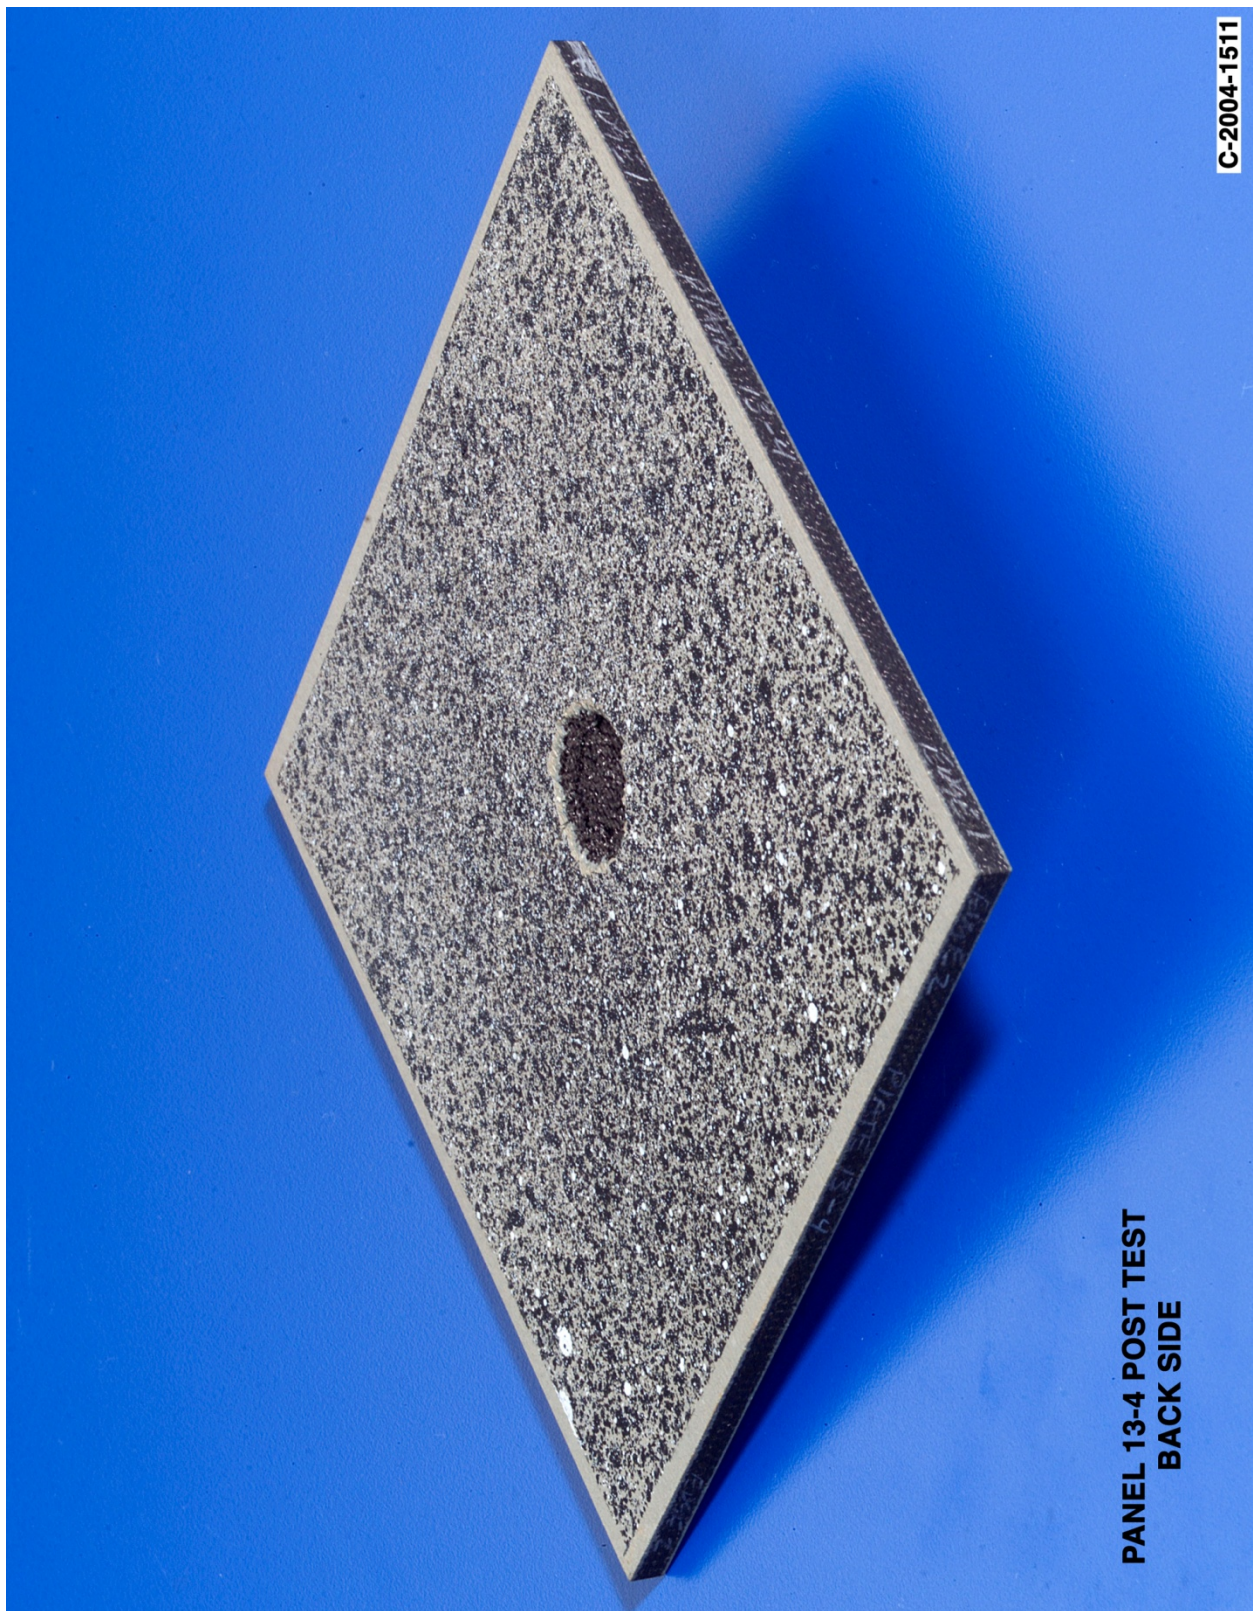
Figure A18-3.—Back face of panel 13-4 at 511 ft/s with a high-density, poly-crystal ice cylinder (nominally 0.66 in. in diameter by 1.66 in.) at 90° impact angle. Test GRCC 69.

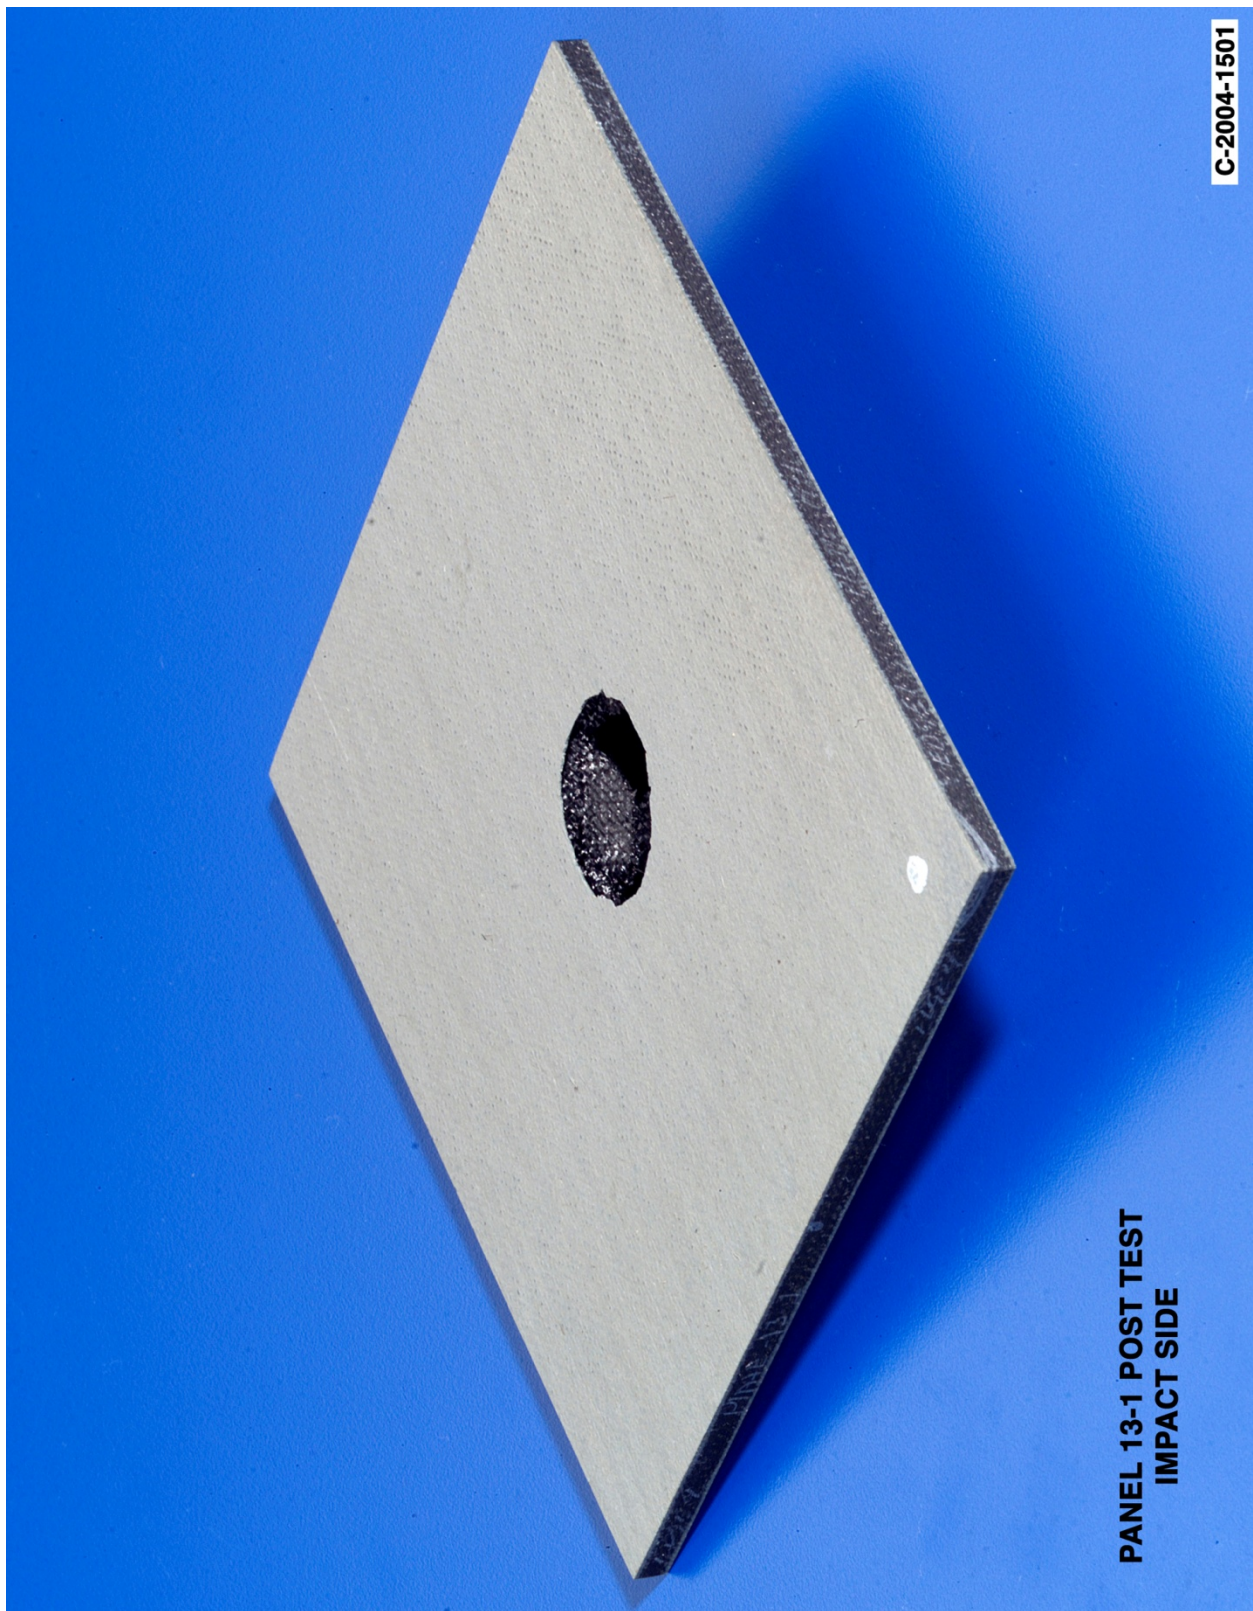
Figure A20-2.—Front (impact side) of panel 13-1 at 641 ft/s with a high-density, poly-crystal ice cylinder (nominally 0.66 in. in diameter by 1.66 in.) at 90° impact angle. Test GRCC 66.

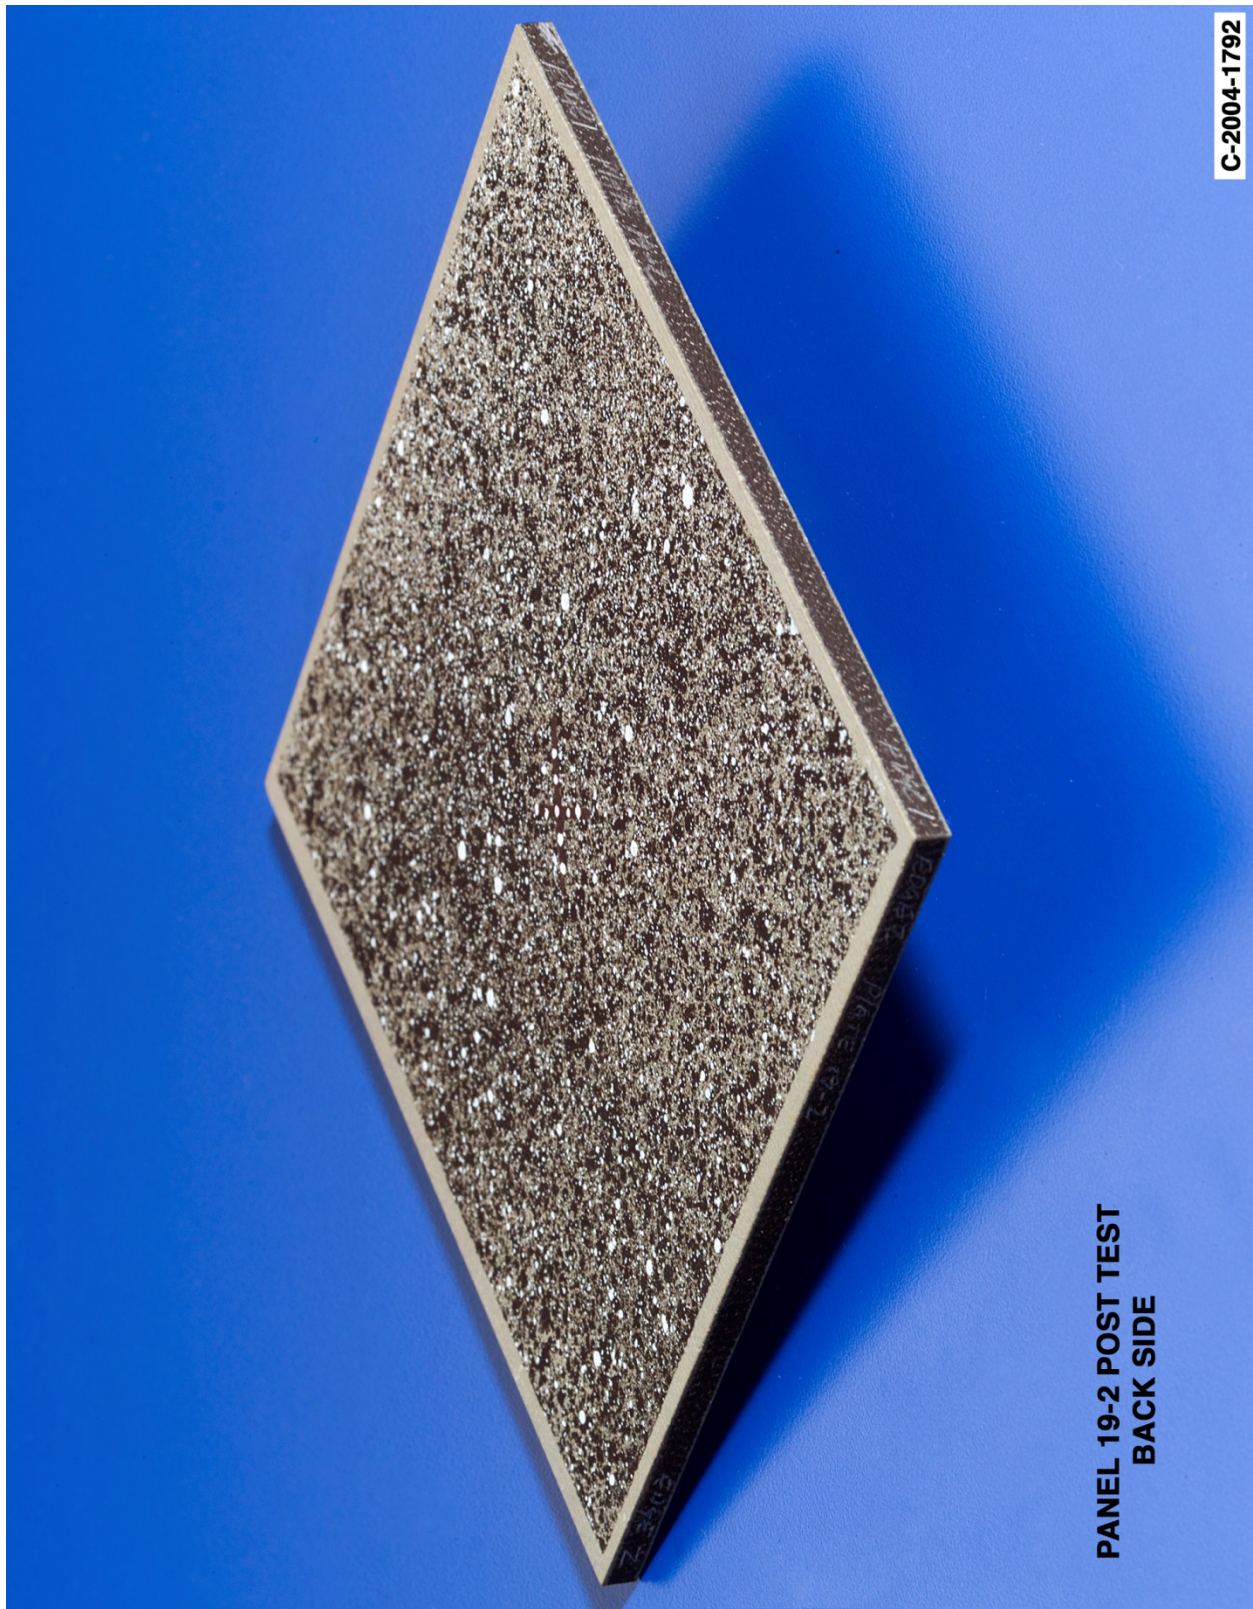
C-2004-1792

Figure B5-3.—Back face of panel 19-2 at 429 ft/s with a high-density, poly-crystal ice cylinder (nominally 0.66 in. in diameter by 1.66 in.) at 45° impact angle. Test GRCC 98.
